# DEVELOPING MITIGATION MEASURES FOR THE HAZARDS ASSOCIATED WITH EARTHQUAKE SURFACE FAULT RUPTURE

Jonathan D. Bray

Ph.D., P.E., Professor, Dept. of Civil and Environmental Eng., University of California, Berkeley  
(440 Davis Hall, MC-1710, Berkeley, CA 94720-1710, USA, bray@ce.berkeley.edu)

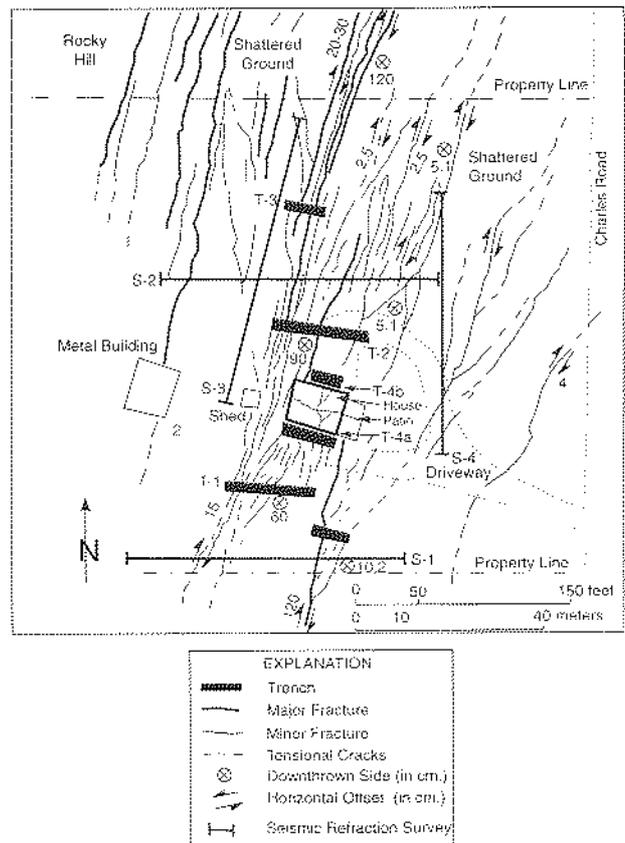
**Figure 5** Ground ruptures and exploration locations at Lannom residence at northern end of the Kickapoo stepover (after Murbach et al. 1999).

Several structures that were damaged by surface faulting were studied after the 1992 Landers Earthquake (Murbach et al. 1999). An example of a house impacted by surface faulting is shown in **Figure 5**. This is a remarkable case history, because fault trenches were excavated along the building foundation, which clearly showed how the underlying ground ruptures damaged the overlying building foundation. The building foundation condition was assessed through mapping and a floor elevation survey using a manometer (**Fig. 6**). Even though the western part of the house was closer to the main fault trace and overlaid larger ground fractures, it received less damage. It appears that damage was limited due to a plastic sheet (Visqueen) underneath it that decoupled the foundation slab from the intense ground shearing underlying it. The plastic sheet limited the transfer of horizontal strain in the ground below the foundation to the slab, keeping the foundation slab in tact. Conversely, the other slab, which was not underlain by a plastic

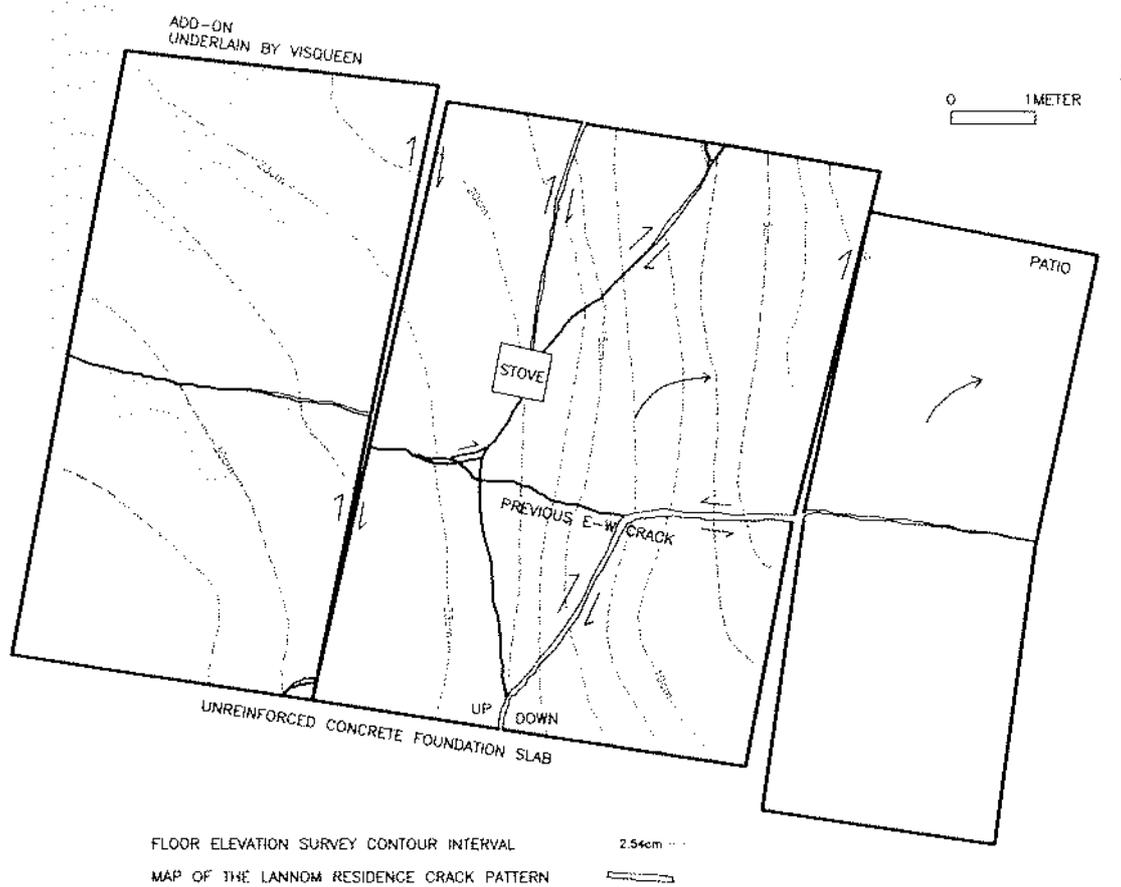
**Figure 6** Deformation of foundation slab of Lannom residence. Left unreinforced concrete foundation slab is underlain with plastic (Visqueen) and right foundation slab is not underlain with plastic. Primary fault scarp is to the left of this building (after Murbach et al. 1999).

sheet, was broken into several discrete blocks due to the nearly complete transfer of horizontal strain through the sandy soils below the foundation. Some horizontal shears were observed in the sand below the foundation, indicating that the soil began to fail as the ground deformation increased and the full strength of the sand stratum was mobilized. The weaker interface strength of the plastic allowed decoupling at an earlier stage of deformation than that in the sand stratum without the plastic sheet. The plastic decoupling layer “shielded” the overlying structure from some of the underlying ground strain.

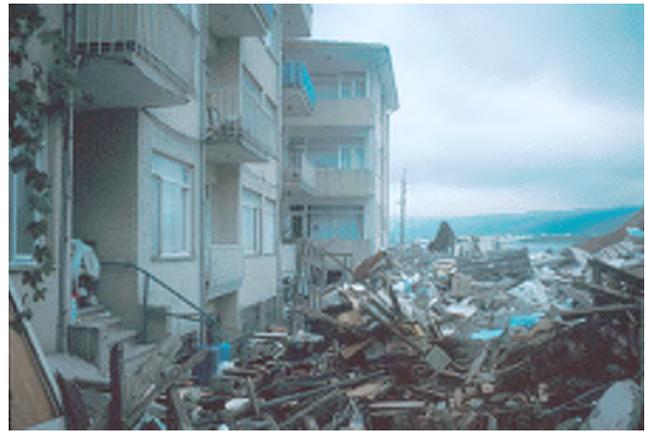
**Figure 7** Apartment house shown on right side of photo, which collapsed due to surface rupture. Fault passes across the middle of the photo between the two standing apartment houses; the far apartment house has been offset about 3 m from its original alignment with the near apartment house (Photo by F. A. Swan from Lettis et al. 2000).

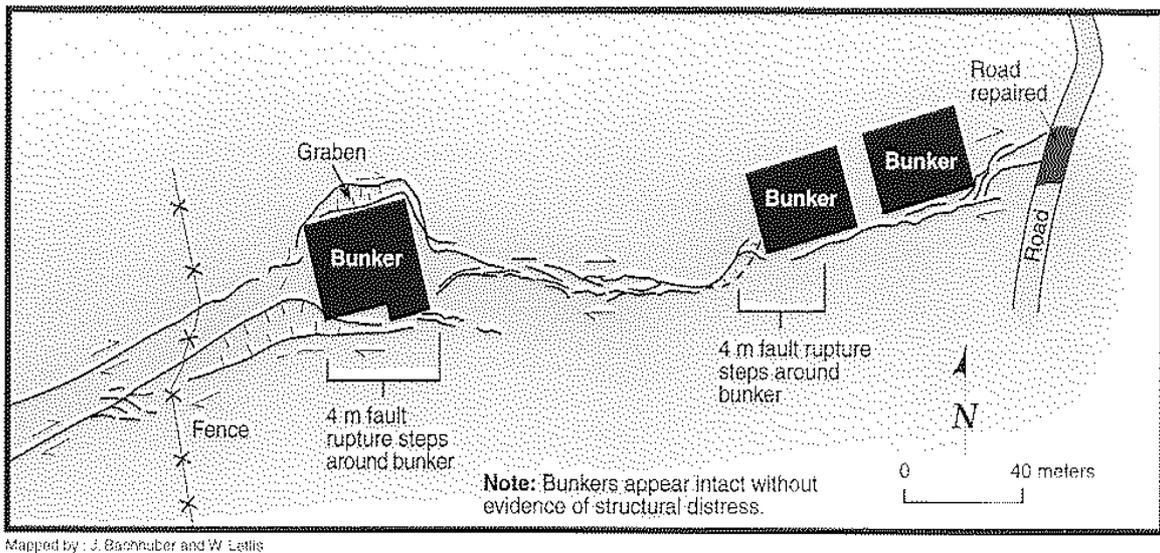
**Figure 8** The stiff concrete bunkers shown in this map were not damaged by the surface fault rupture that was diverted around them (Mapped by J. Bachhuber and W. Lettis; from Lettis et al. 2000).

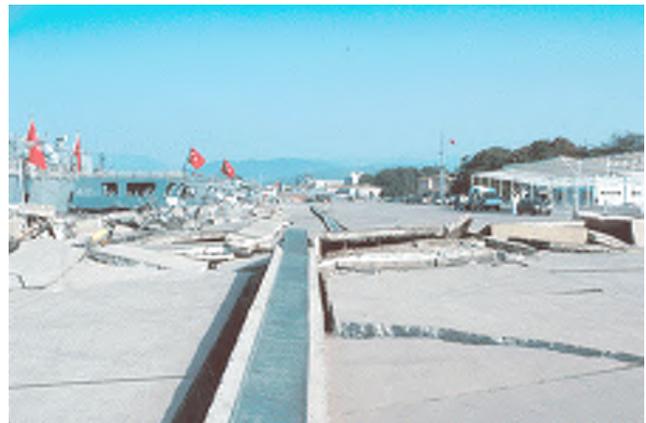
**Figure 9** Fault offset of about 2 m heavily damaged this dock at the Gölcük Naval Base, which was fixed to the ground with piling (Photo by F.A. Swan; from Lettis et al. 2000).

members to weaker connections, joints, or elements of the docks, or was accommodated by global rotation, thereby spreading the damage over a wider area (Fig. 9).

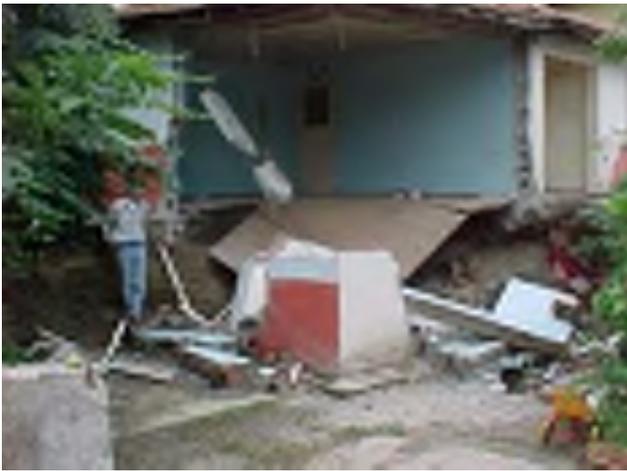
The Gölcük pull-apart basin is formed due to the right-releasing stepover between the Gölcük and Sapanca fault segments. Surface fault rupture in this area was expressed by up to 2.4 m of vertical displacement along a normal fault through the city with widespread tectonic subsidence of the basin, which caused inundation along the coast. Several structures overlying the dip-slip fault displacement were heavily damaged due to extreme differential vertical ground movements (Fig. 10a). Approximately

**Figure 10** (a) Extreme differential ground movement as a result of normal faulting in Golcuk destroys this apartment building; whereas, (b) apartment building that is located just off of fault scarp was not damaged, (Photos by J. D. Bray).

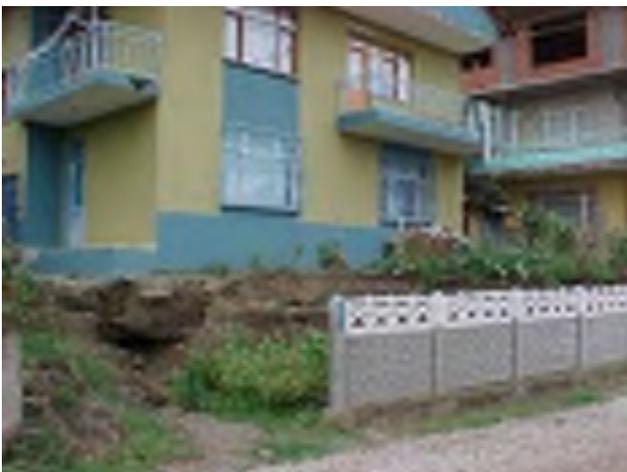
(b)

2.4 m of vertical displacement occurred within 1 m of a two-story concrete frame apartment building that was undamaged by fault rupture or by strong ground shaking (**Fig. 10b**). There were other cases of buildings in Gölcük located adjacent to the main trace which were only lightly damaged. However, buildings crossing the main trace often collapsed and some buildings located in subsidiary fault zones were heavily damaged by fault movement, such as a large assembly facility at the Ford-Otosan Plant.

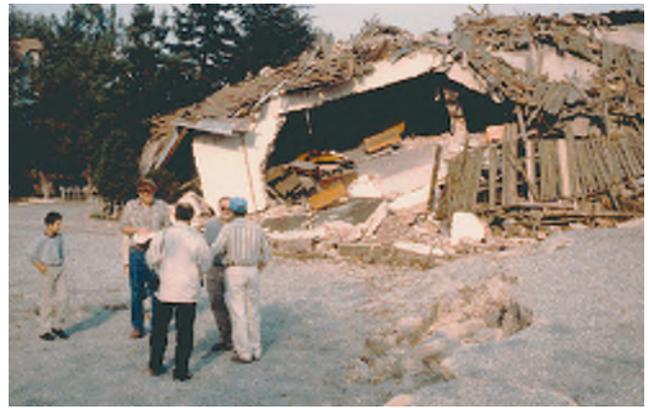
**Figure 11** Fault rupture destroyed a primary school building in Kullar (Photo by L.S. Cluff; from Lettis et al. 2000).

0.5 m of vertical displacement caused partial collapse of the town's primary school (**Fig. 11**). Strong ground shaking did not significantly damage surrounding buildings; thus, collapse of the primary school was most likely due to fault rupture. On the adjoining fault trace, about 1 m of lateral displacement directly intersected a two-story building. Displacement on the fault stopped at the building and slip was transferred to an adjoining, sub-parallel fault trace. About 1 km west of Lake Sapanca, the fault rupture directly intersects a school building (**Fig. 12**). About 1 to 2 m of distributed fault rupture was arrested by the building and forms a left en-echelon step around the building. The building foundation and walls were not damaged by the fault rupture.

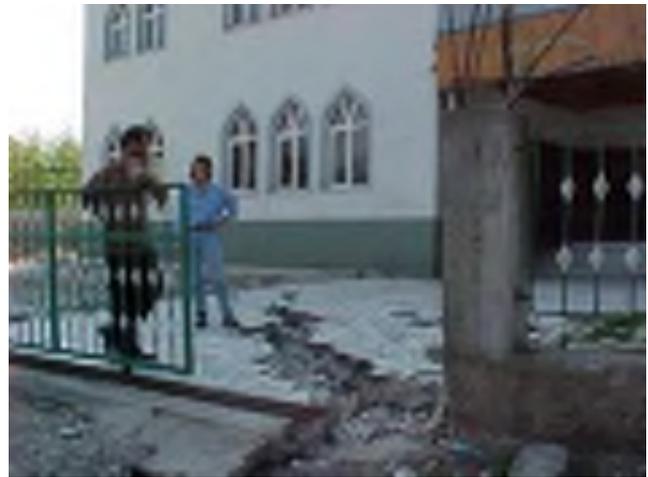
**Figure 12** Fault traversing beneath the corner of the Koran School, yet the school underwent only minimal damage (Photo by E. Rathje).

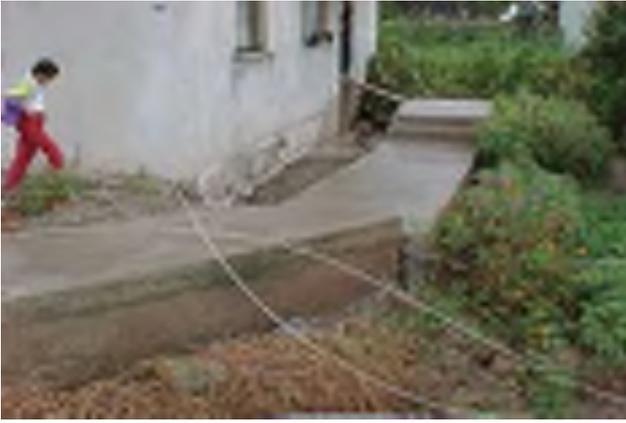
**Figure 13** Well-built 2-story house in Arifiye is not damaged although the primary surface fault scarp passed beneath it with over 3 m of right-lateral displacement. In response to the underlying fault movement, the stairs leading to the house have been offset relative to the house (Photo by J.D. Bray).

Approximately 3 to 5 m of right-lateral displacement occurred on the Sakarya fault segment. Fault rupture extended through several small towns. Within the Town of Arifiye, about 3 m of fault rupture extended beneath a 2-story residential house without damaging it (**Fig. 13**). The house foundation consisted of a shallow, 1 x 1 m reinforced concrete grid. Apparently, the shallow foundation was sufficiently stiff and strong to hold the building intact and to allow the foundation to decouple from the underlying alluvial soil on the south side of the fault. The decoupled side at the building was dragged about 2 m eastward by the north side of the fault. About 1 m of lateral displacement was consumed by compression of the soil along the margins of the house.

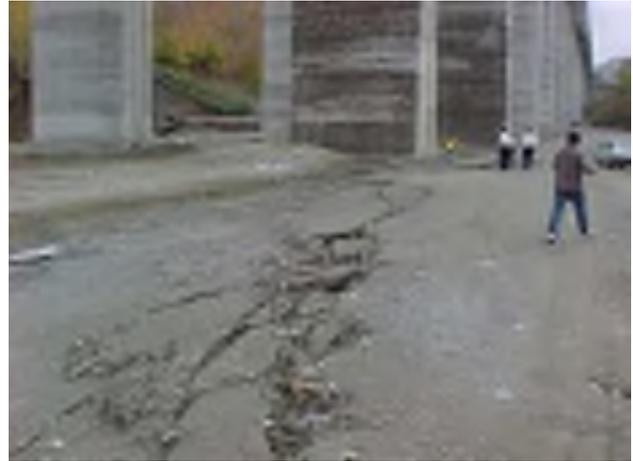
Fault rupture from the 1999 Duzce earthquake passed directly underneath the Bolu Viaduct, which is a state-of-the-art base-isolated bridge structure that was nearly complete at the time of the earthquake. Several meters of right-lateral fault displacement passed at an oblique angle through the viaduct. As shown in **Figure 14**, the ground movements rotated the pier relative to the deck it supports. The twisting of the pier foundation produced heaving of soil due to a passive earth pressure failure and ground cracking due to an active earth pressure failure on opposite corners of the foundation. The surface rupture, which followed a nearly linear path through this area, was diverted around the relatively strong embedded pier foundation. The fault rupture produced extensive damage to the viaduct, as the deck was displaced

**Figure 14** Interaction of 1999 Duzce earthquake surface fault and Bolu Viaduct: (a) several meters of right-lateral fault rupture passes at oblique angle through viaduct and directly through one pier, (b) pier is twisted as shown but is not fractured as it rotates in response to underlying fault movement. Ground rupturing is diverted around pier (Photos by J. Bray).

relative to its support. The fault movement caused the base-isolators to undergo permanent displacement, and several deck sections nearly fell from their supports.

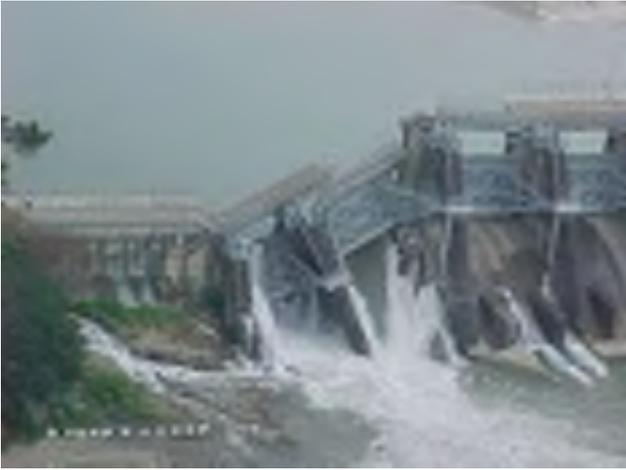
**Figure 15** View to the east of surface fault rupture through Shihkang Dam (Photo by J.D. Bray).

The fault rupture through the Shihkang Dam is a remarkable case (**Fig. 15**), because it represents the first time that a significant dam has been directly offset by primary fault rupture. A number of dams have been knowingly or unknowingly constructed atop potentially active fault traces, so this is an important case to study (Bray et al. 1992). Shihkang

Dam was offset approximately 9 m near its right abutment due to primarily dip-slip rupture. In addition, the dam crest south of the failure experienced warping associated with a broad, west-trending anticlinal axis (Lee et al. 2000). This dam did not fail catastrophically, but it did lose its function of providing water supply for the City of Taichung.

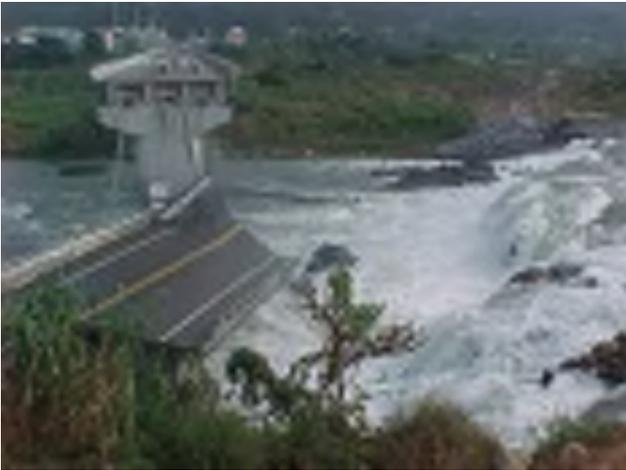
**Figure 16** Collapse of Highway 13 bridge north of Fengyuan due to 6 m fault movement (Photo by J.D. Bray).

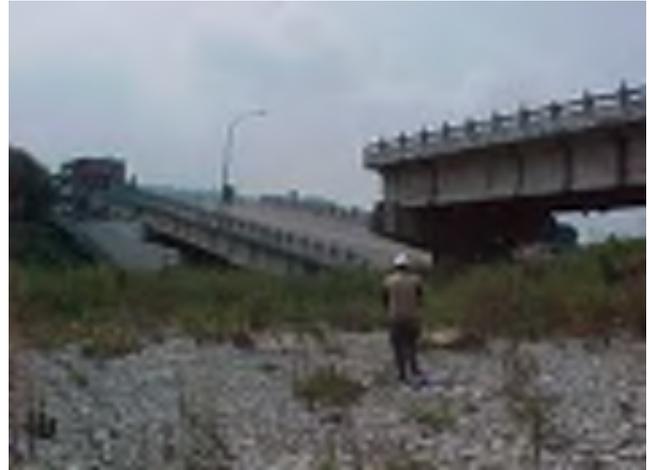
**Figure 17** Collapse of bridge directly east of Shihkang Dam due to tectonic compression (Photo by J.D. Bray).

to be two poorly expressed opposite dipping reverse faults near each bridge abutment (**Fig. 17**).

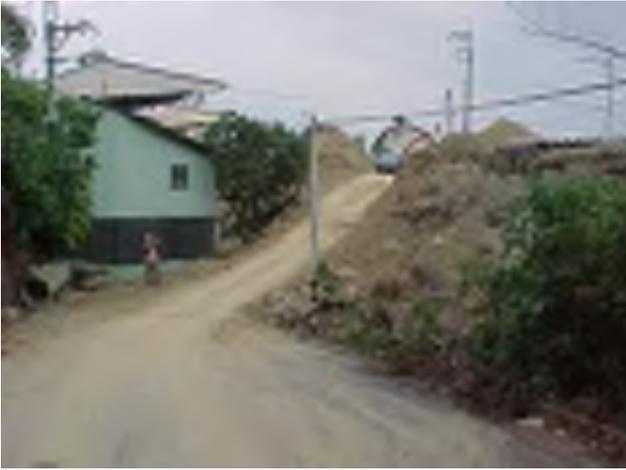
**Figure 18** Fault scarp that is about 5 m high passes close to, but does not damage, a simple steel-framed warehouse that is located on footwall side of shallow thrust fault (Photo by J. Bray).

With regard to building damage, there was relatively little differential ground deformation on the footwall block and consequently less building damage (**Fig. 18**). Those buildings that were damaged were pushed laterally when the hanging-wall thrust over the footwall, but this occurred only in close proximity of the main fault trace. Buildings straddling the fault trace underwent severe differential ground movements and were typically heavily damaged (**Fig. 19**). However, significant ground deformation expressed by warping or secondary ruptures occurred on the hanging-wall, and this damaged many buildings situated on the

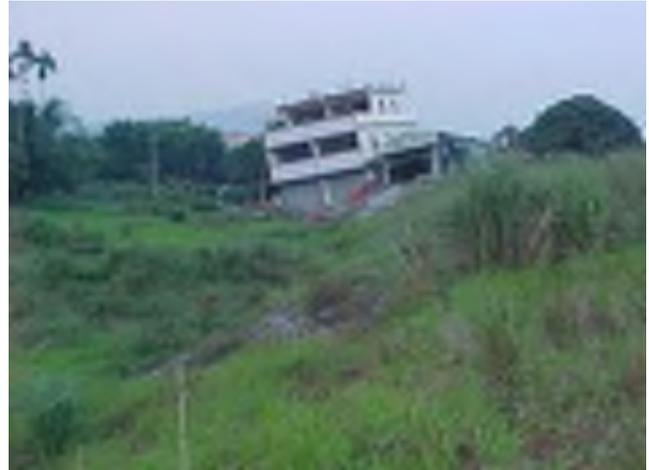
**Figure 20** North-facing subsidiary fault in hanging-wall block and local ground deformation damages this house and warehouse. This site is located southeast of Shihkang Dam and south of the primary fault ruptures running along the Tachia River in this area (Photo by J. Bray).

hanging-wall (**Fig. 20**). Ground deformation was greatest along the fault scarp and about 20 m from it on the hanging wall, but significant ground deformation was observed as much as 100 m from the fault scarp and further when back-thrust faults displaced hundreds of meters from the fault scarp on the hanging-wall block. Where the surface deformation was dominated by anticlinal folding, building damage occurred over a substantially broader area. The wider zone of severe building damage appears to be a result of the broader width of ground deformation in the hanging-wall anticline. These observations along with similar observations from other reverse fault events (e.g. Bray et al. 1994a) indicate that building zonation along reverse faults should be asymmetric, with narrow setbacks being appropriate on the footwall side and wide setbacks being necessary on the hanging-wall side.

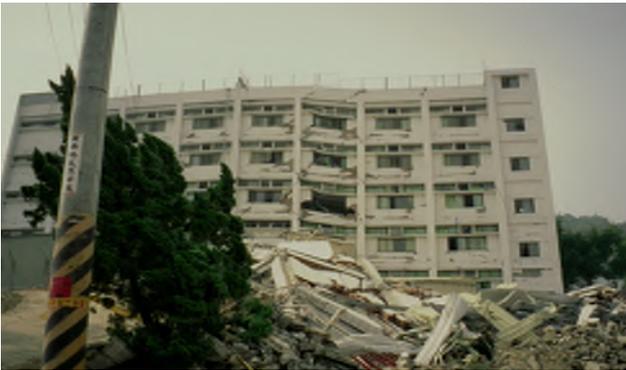
**Figure 19** The primary trace of the Chelungpu fault passed beneath this apartment building in Wu Feng, producing about 2 m of vertical displacement through the building (Photo by K. Kelson).
