OWNER: State of Alaska Department of Transportation and Public Facilities (DOT&PF)

PROJECT TITLE: KTN. N. Tongass Bridge Improvements – Waterfall Creeks

This project replaced two bridges, First and Second Waterfall Creeks (Bridge Numbers 414 and 415), on the North Tongass Highway in Ketchikan. The project involved challenging site conditions: two deep ravines constrained by exposed rock faces, overhead utilities, and narrow right-of-way. There are no alternate routes so detour bridges were required to maintain traffic. Additionally, the COVID pandemic escalated midway through construction, adding another complication to the construction challenges.

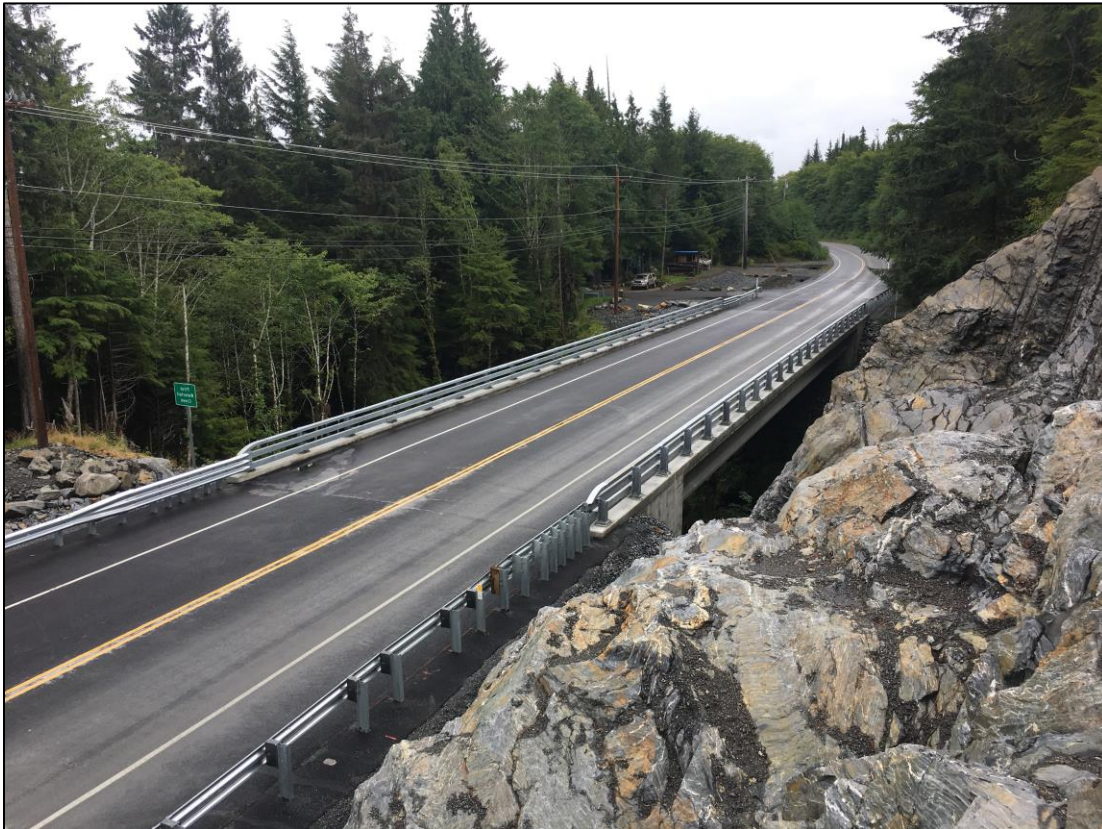
Completed First Waterfall Creek Bridge

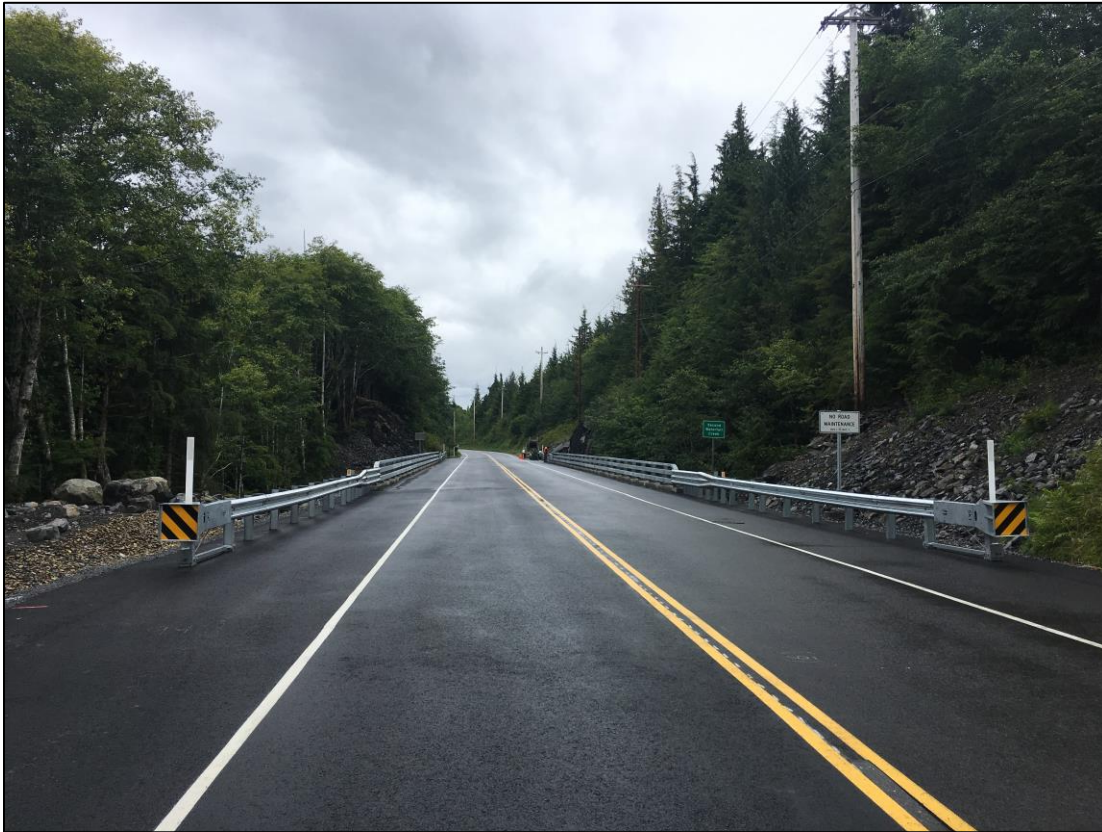
Completed Second Waterfall Creek Bridge

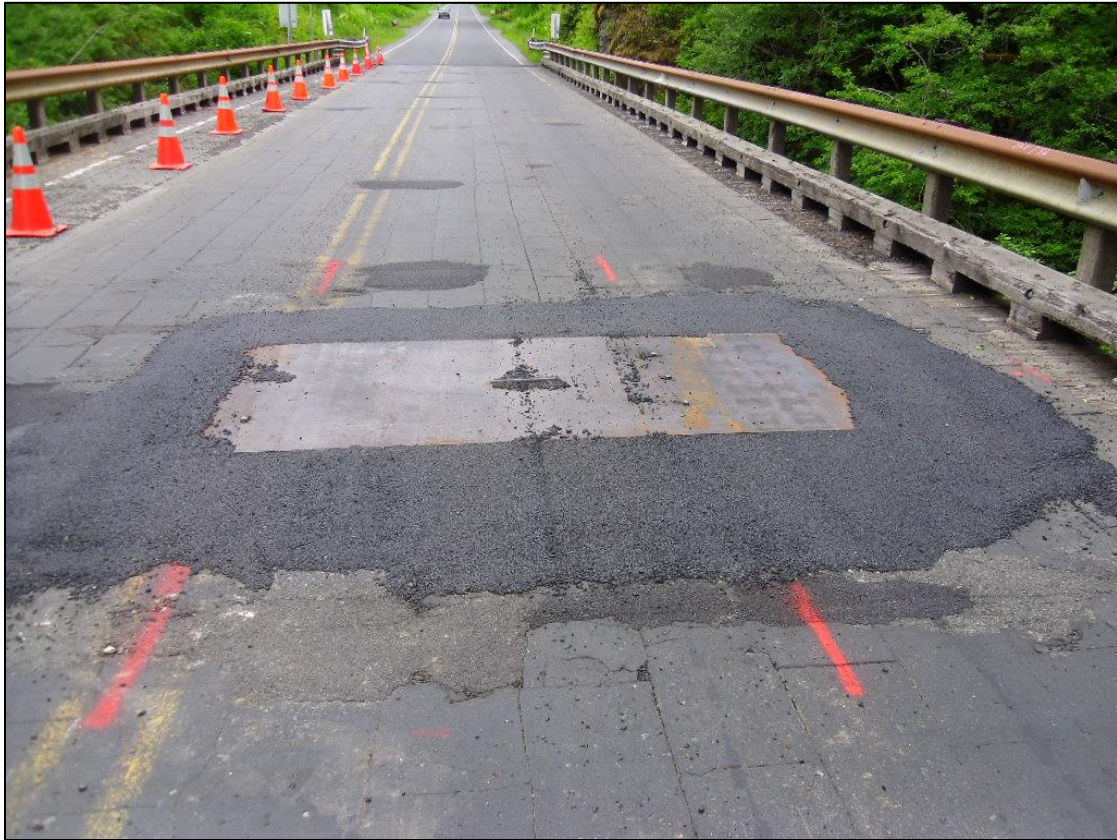
The Old First Waterfall Creek Bridge with Closed Shoulder and Deck Repairs

The old First and Second Waterfall Creek Bridges were built in the early 1960s by the US Department of Commerce Bureau of Public Roads. The bridges were constructed with timber girders and a timber deck with an asphalt tile wearing surface. Considering the harsh Southeast Alaska climate 60 years is a reasonable life for timber structures, but the bridges were in need of replacement. The roadway over downstream exterior girder at First Waterfall Creek had to be closed to traffic due to excessive cracking and deterioration. The deck of First Waterfall Creek had numerous repairs and worn asphalt tiles. Both existing bridges were load limited such that Ketchikan fire trucks could not cross the bridges when full of water and some fuel delivery trucks were prohibited from crossing the bridges. DOT&PF's large snow plows were also too heavy for the existing structures. These limitations had direct impacts to the safety and well-being of the local residents. The new bridges allow all legal loads with no restrictions to again cross the bridges.

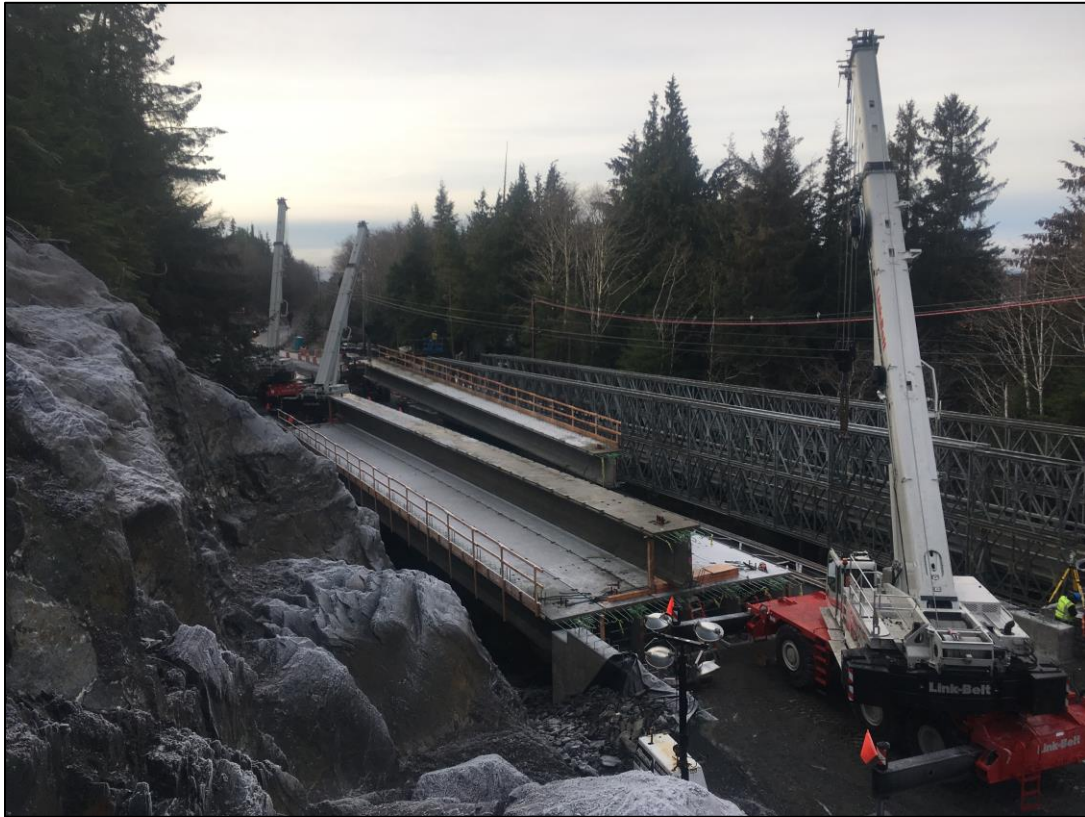
Construction of First Waterfall Creek Bridge with Tight Constraints

Due to the load postings of the bridges, DOT&PF was interested in accelerating design and construction schedules as much as possible. However, the close proximity of an access driveway and adjacent property owners meant the right-of-way process could not be rushed or circumvented. Since the project could not be bid sooner, a requirement was added to the contract requiring a temporary bridge to be installed at First Waterfall Creek as soon as possible. Payment for mobilization was tied to opening of the temporary bridge and an interim completion date item was added to the contract. Both incentives and disincentives were used to ensure this part of the project would be completed quickly.

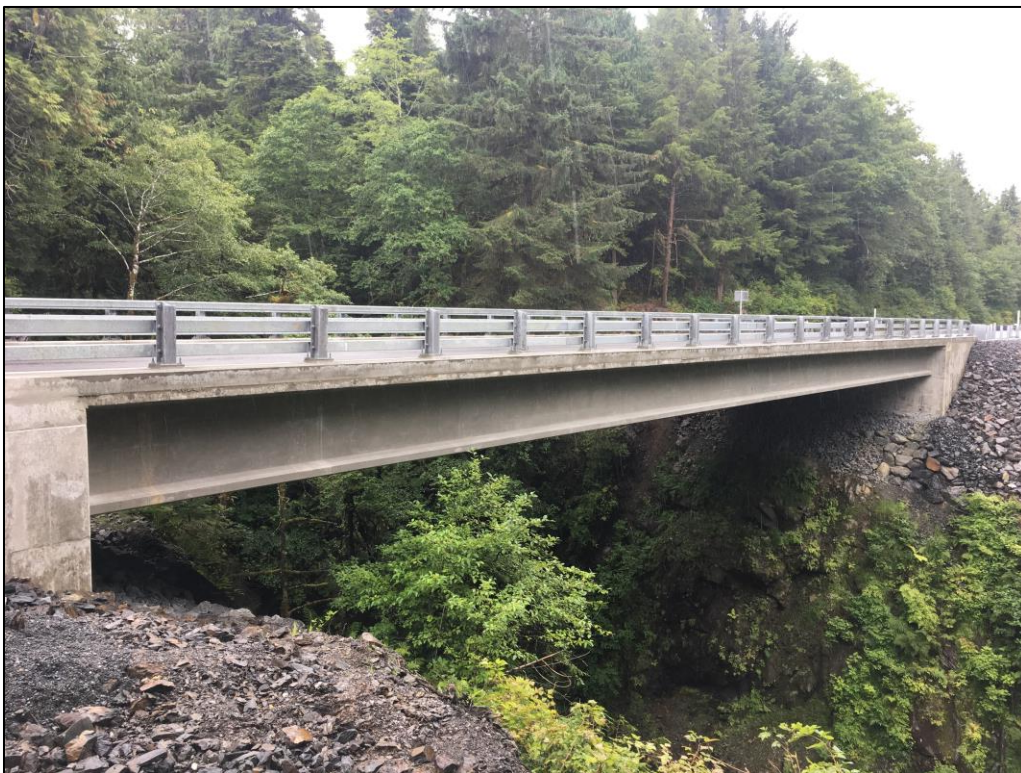
Elevation View of the Completed First Waterfall Creek Bridge
