Re: 2025 ASCE Juneau Branch Outstanding Project of the Year Nomination - Haines 2020 Flood Damage Repairs

Overview

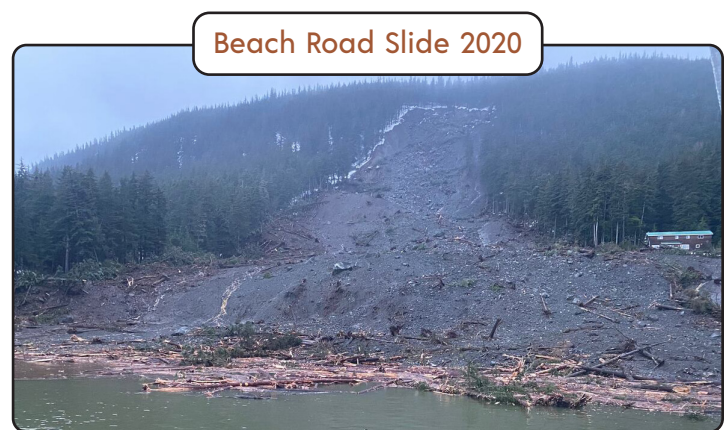
The Beach Road landslide in December 2020 as seen from a boat in Portage Cove. The slide was approximately 500–600 feet wide and 2,500 feet long. Photo by Alaska State Troopers.

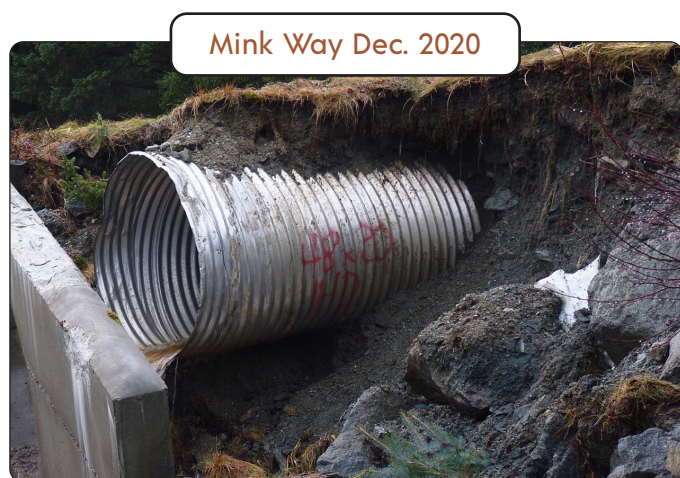
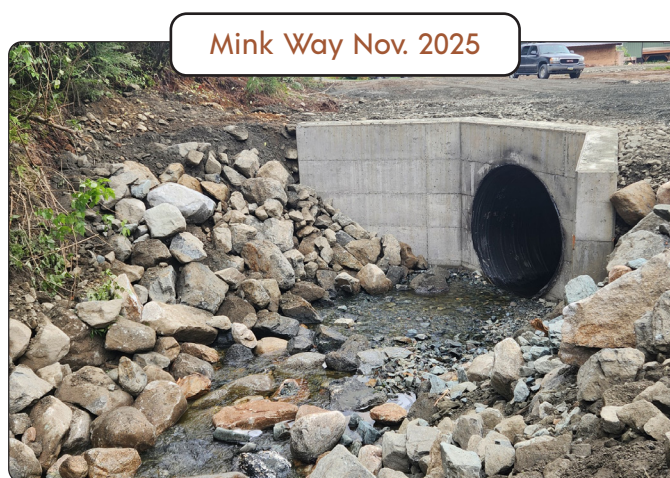
Building on that knowledge, proHNS selected SRPE for the permanent repair at Mink Way following the failure of a 48-foot-long, 72-inch corrugated metal pipe culvert during the December 2020 storm. During that event, high flows carrying rocks and debris scoured the channel and punched holes through the bottom of the existing steel culvert; the toe wall also failed, and the roadway washed out. The final design replaced the failed pipe with 55 linear feet of 84-inch SRPE pipe, paired with reinforced concrete headwalls and wingwalls. SRPE combines steel ribs encased within the pipe wall with a smooth polyethylene interior, providing both the structural resistance needed to withstand debris-laden flows and the hydraulic efficiency and corrosion resistance required for long-term performance.

This approach allowed the Borough to move beyond in-kind replacement and instead implement a FEMA-eligible permanent repair that directly addressed the observed mode of failure.

proHNS applied lessons learned from prior regional experience to deliver an innovative culvert solution at Mink Way, part of the 14-site Citywide Culverts and Minor Road Repairs project. Several years ago, proHNS specified steel-reinforced polyethylene (SRPE) pipe for the City and Borough of Juneau's Douglas 4th Street Utilities and Drainage Improvements at the Bear Creek culvert. That project provided experience with SRPE and demonstrated its suitability for Southeast Alaska's high-precipitation, corrosive environment, as well as its ability to withstand high-energy flow conditions.

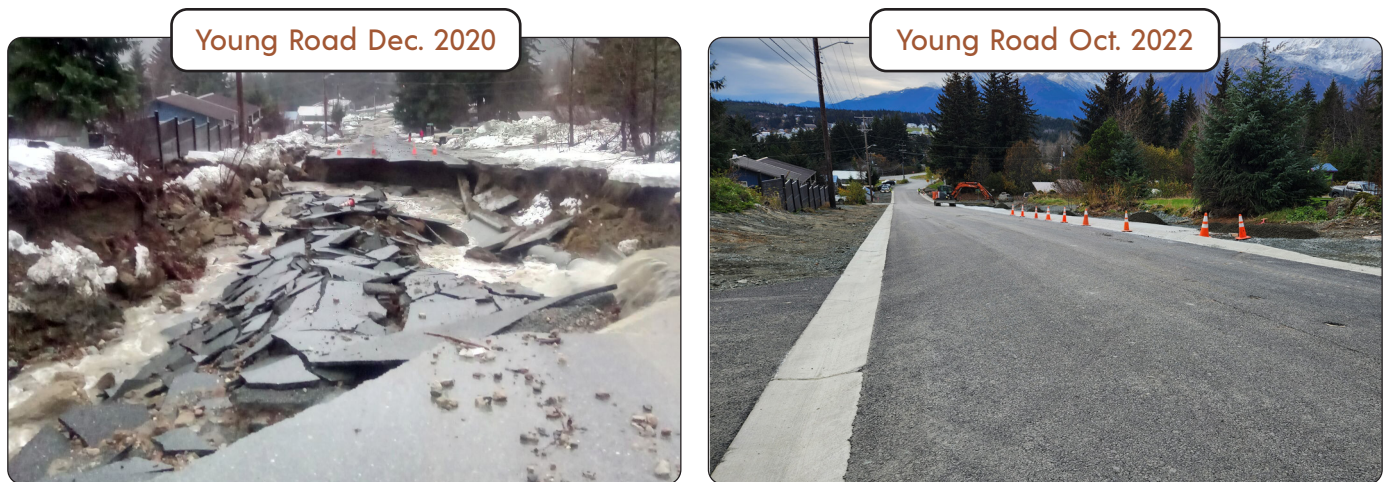
Repairs to Young Road were prioritized due to both the severity of storm damage and the corridor's role in the Borough's transportation network. The roadway is the sole access route for a significant portion of the Haines population, providing connection to multiple residential areas, including the Skyline subdivision. Photo at left from Darwin Feakes.

- ☑ **Young Road:** Where an existing 48-inch culvert could not be upsized due to site constraints, design focused on improving maintainability and safely managing exceedance flows. Mitigation measures included a sloped inlet headwall with trash rack, adjustment of a previously buried downstream manhole to finished grade for routine debris removal, and the addition of a redundant surface overflow conveyance system. A roadside overflow ditch was constructed to route overtopping flows to a dual enclosed stormwater system approximately 450 feet downstream. The system was designed to split extreme flows between east and west storm lines by offsetting inlet elevations, reducing overtopping risks.

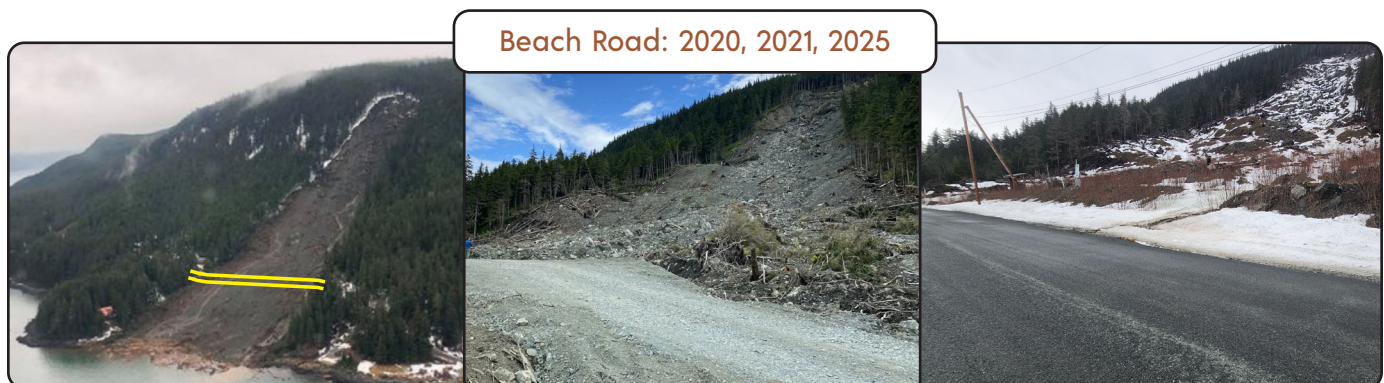
Left: The Beach Road landslide was 500-600 feet wide and wiped out the existing gravel roadway (location shown in yellow).
Photo from Jacob Cheeseman.

Center: Temporary repairs included a basic gravel roadway that restored access for residents living beyond the slide.
Photo from University of Alaska Fairbanks.

Right: Permanent repairs constructed a paved roadway and installed large cross culverts through the slide zone.

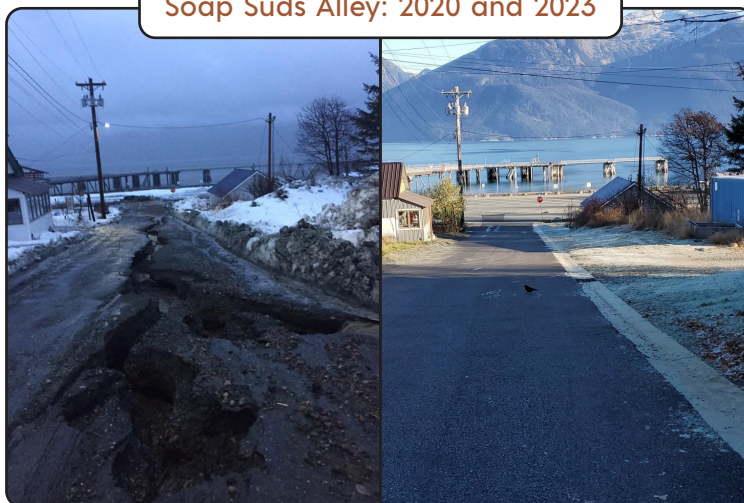
Soap Suds Alley: 2020 and 2023

FEMA-funded repairs to Soap Suds Alley included reconstruction of the roadway structural sections, asphalt pavement, curbing, and culverts. Concurrent with this work, the Haines Borough funded \$275,000 in water system improvements, including installation of 300 linear feet of 8-inch HDPE pipe and replacement of 23 water services. By planning and sequencing the Borough-funded improvements alongside FEMA-funded repairs, our team was able to minimize disruption to the neighborhood and cost-effectively address two issues at once.

service replacements on Dalton Street, replacement of numerous aging water services along Soap Suds Alley, and water service replacements paired with new sidewalk construction on Second Avenue. By completing locally funded improvements at the same time as FEMA-funded repairs (while roadways were already excavated and contractors mobilized) the Borough avoided duplicating costs for activities like paving, and surface restoration. This coordinated approach is estimated to have reduced local project costs by as much as 75 percent compared to delivering the same improvements as standalone projects.
